**UNIVERSITY OF MICHIGAN HOSPITALS AND HEALTH CENTERS
FACILITIES PLANNING AND DEVELOPMENT**
2101 Commonwealth, Suite B
Ann Arbor, MI 48105-5759

MEMORANDUM

SUBJECT: Domestic Water Analysis- Premature Failures in UMH Domestic Hot Water Systems

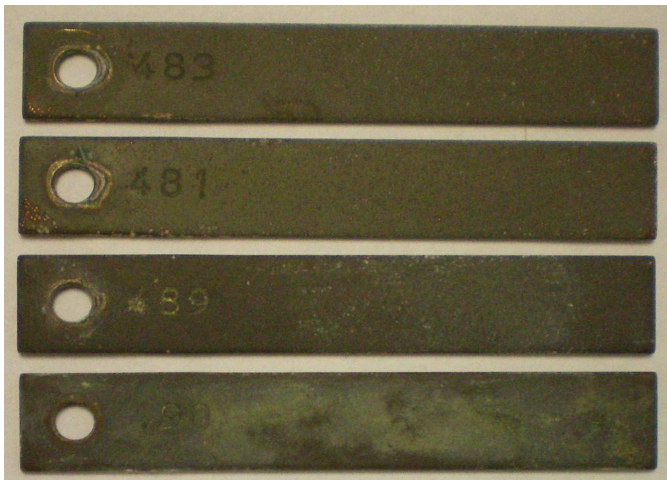
Coupons Before Cleaning

| This coupon appeared dark gray in color with spots of lighter gray, mainly on the trailing end of the coupon. There is no metal loss visible | | | |
| This coupon appeared dark gray in color is tiny white spots visible, mainly on the trailing end of the coupon. There is no metal loss visible | | | |
| This coupon appeared a dull gray in color with tiny white spots visible, mainly on the surface near on the trailing half of the coupon. There is no metal loss visible | | | |
| This coupon appeared a dull gray color with a patch of white/green near the center of the coupon. There is no metal loss visible. | | | |

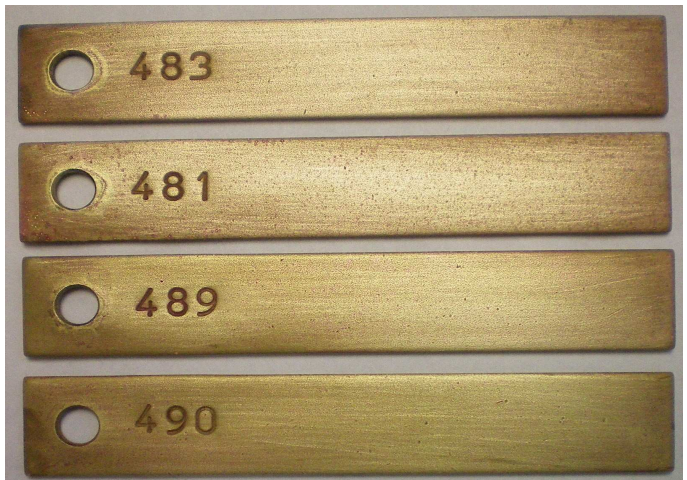
Coupons After Cleaning

UH – Both sets of coupons showed poor results in respect to corrosion. 60 day rate was .70 mpy. 90 day rate was .51 mpy. Of particular note and concern was the significant amount of pitting on the coupons. Localized pitting magnifies corrosion rates and leads to premature, localized failure of system piping – this type of failure is typical of what is seen at the hospitals. Pitting also contributes corrosion products to the system which can lead to deposition/plating on other metal surfaces. This deposition can lead to additional pitting and failure other system metallurgy.

| This coupons has many tiny pits on the surface of the coupon. It also has some discoloring around the edges. These spots are not the Dark gold of Brass but are more of a copper/brown. | | | |
| The dull gray coating and the white spots were removed during cleaning. The color is present but darker then normal especially on the ends and edges of the coupon. There are a few tiny pits visible on the coupon. | | | |
| The dull gray coating and the green/white patches were removed during cleaning. The color is present but darker then normal especially on the ends and edges of the coupon. | | | |

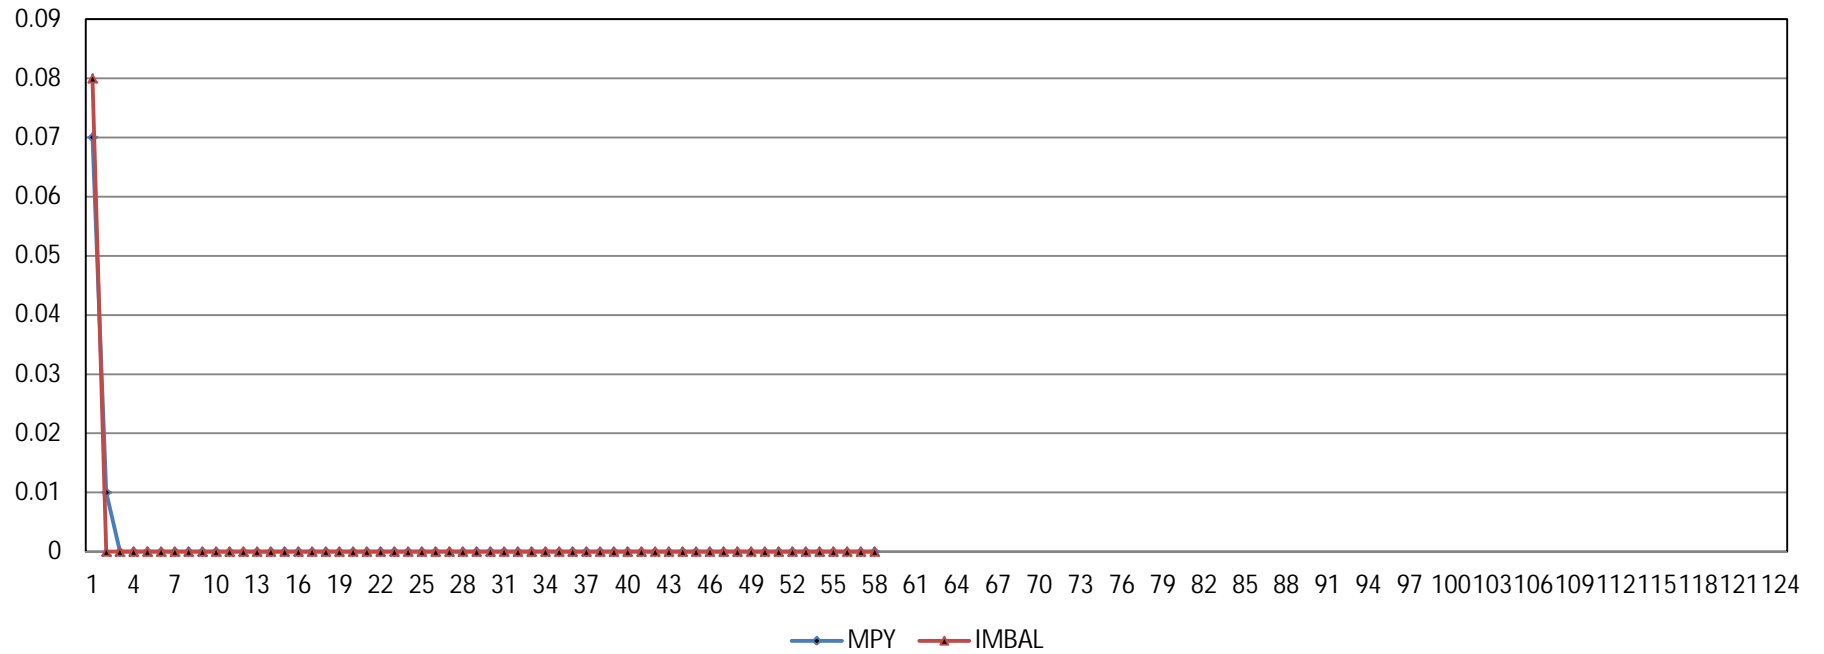
Domestic Hot Water Supply 316 SS

Simultaneously CPP conducted a corrator probe test of the hot water delivered out of CPP. This test studied the effects untreated domestic hot water has on various materials common in our domestic hot water system. This study looked at corrosion and imbalance values (indicative of pitting problems) for 304 SS, 316 SS and admiralty brass for a 3 month period. Attached are the results from this test. In summary, this test indicated that 304 SS and 316 SS show little if any corrosion and/or pitting problems. In contrast, admiralty brass exhibited poor corrosion rates (>0.5 mpy) and poor pitting potential (>6uA IMB). In addition, this study looked at the relationship amongst corrosion

potential, pitting potential and conductance of the water. In general, higher conductance values were shown to increase corrosion rates and increase pitting potential.
